TECH TALK

WIX WL10025

OE OX 813/1
BMW 11428575211

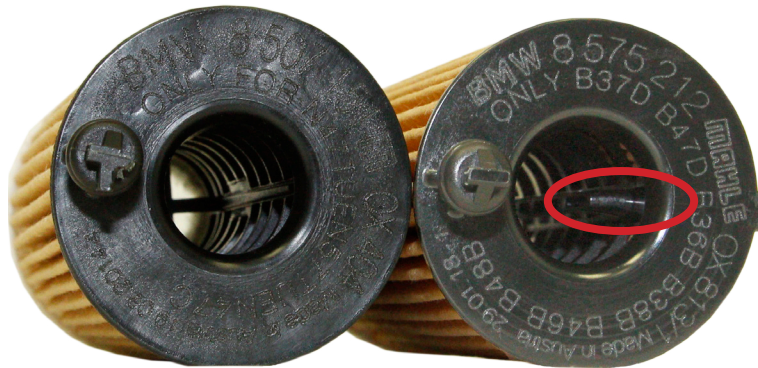
The WIX WL10025 is not a suitable replacement filter for applications requiring the OE filter OX 813/1 (BMW 11428575211). The OX 813/1 has an alignment tab inside of the filter center tube. The tab fits into a slot in the oil housing ensuring proper alignment during filter installation. The WIX WL10025 does not have the alignment tab and can be installed incorrectly resulting in low oil pressure during vehicle operation.

The correct WIX replacement filter for the OE OX813/1 (BMW 11428575211) is the soon to be available WIX WL10358.
